An Arboricultural Assessment of the Tree Vegetation within and Adjoining the Site Area Known as 'Rockbrook', Carmanhall Road, Sandyford, Dublin 18.

Prepared for: Ires Residential Properties Ltd

Date: 5th December 2018

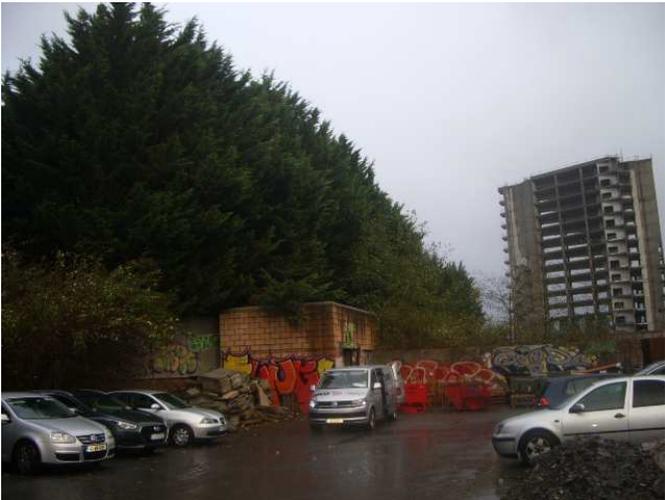
Tree No.	Tree Species	Ht. (m)	Stem Dia. (mm)	Branch Spread (m)	C-Ht. (m)	Age Class	Phys. Con.	Structural Condition Other Comments	Preliminary Recommendation	Remain Contribute in years	Cat. Grade								
								N-north S-south E-east W- west Phys.-physiological.	MS- multi-stemmed A- average										
		A Condition Assessment of the tree vegetation within and adjoining the site area known as 'Rockbrook', Carmanhall Road, Sandyford, Dublin 18.																	
Tree Line No.1	Leyland Cypress <i>Cupressocyparis leylandii</i>	<p>It is located on the inside of the boundary railing with 'Carmanhall Road' and is currently cordoned off from the road by hoarding.</p> <p>They are of an early-mature age class in fair condition physiologically and in fair/ poor condition structurally. They had initially been cut / managed in the past at a height of c.4meters (m) but have since been allowed to grow up with tall upright stems from these cut positions. Excavations and construction activities have occurred on the northern side within close proximity and have resulted in soil and root damage to the point that their stability could be undermined at their current size. Their crown overhang into the site area has also been cut back, particularly on lower branches.</p> <table border="1" data-bbox="427 791 1167 890"> <thead> <tr> <th>Ht. (m)</th> <th>Stem Dia.(mm)</th> <th>Branch Spread (m)</th> <th>C-Ht. (m)</th> </tr> </thead> <tbody> <tr> <td>A 15</td> <td>A 400</td> <td>A 5N/5S/2E/2W</td> <td>A 0</td> </tr> </tbody> </table>							Ht. (m)	Stem Dia.(mm)	Branch Spread (m)	C-Ht. (m)	A 15	A 400	A 5N/5S/2E/2W	A 0	<p>They will either need to be reduced in height by 3-4m to help improve their stability or be removed completely to allow for more appropriate planting within this area.</p> <p>Their retention would only be seen as a short-term solution and their removal will be necessary as part of active management.</p>		U
Ht. (m)	Stem Dia.(mm)	Branch Spread (m)	C-Ht. (m)																
A 15	A 400	A 5N/5S/2E/2W	A 0

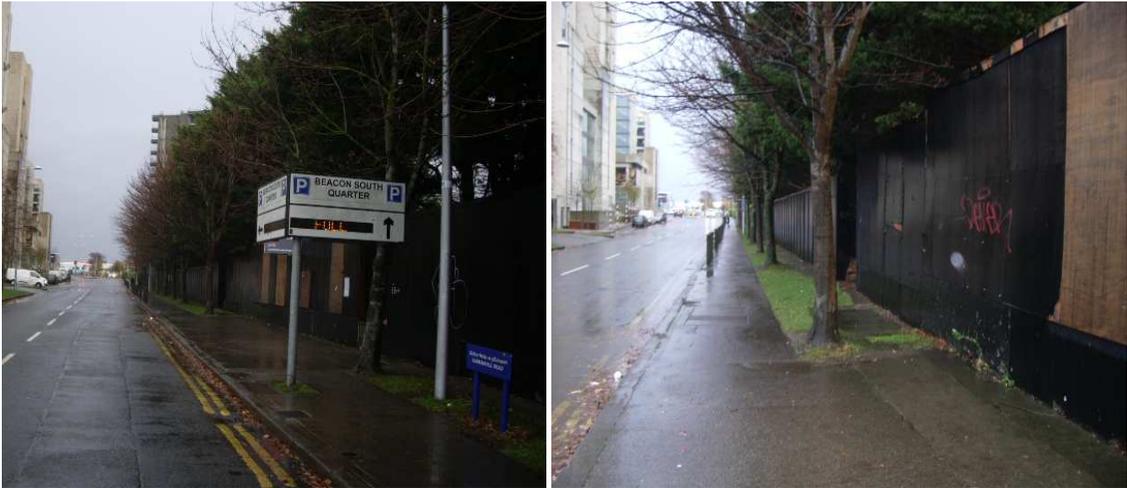
Tree No.	Tree Species	Ht. (m)	Stem Dia. (mm)	Branch Spread (m)	C-Ht. (m)	Age Class	Phys. Con.	Structural Condition Other Comments	Preliminary Recommendation	Remain Contribute in years	Cat. Grade		
								N-north S-south E-east W- west Phys.-physiological.	MS- multi-stemmed A- average				
Tree Line No.2	Norway Maple <i>Acer platanoides</i> London Plane <i>Platanus xhispanica</i>	<p>The following trees are growing on a linear grass verge (c.2m wide) between the public footpath and the site boundary and are located within c.0.5m of the footpath edge.</p> <p>It consists of 9No. Norway Maple cultivars and 1No. London Plane and they are of a semi-mature age class. They are of some prominence within this area and they extend beyond the site boundary in an eastwards direction. They are growing within hostile growing conditions with potential to cause structural damage to the path surface and roadside kerb as they grow in size which is becoming evident in some locations. It is evident that services run within this grass verge with some junction boxes located between the trees. These trees are being overcrowded/ suppressed on their northern side by Tree Line No.1 and have slightly asymmetrical crowns weighed towards the road as a result. They have received pruning in the past, particularly on lower branches in order to maintain clearance with the road and public footpath.</p>						<p>They would benefit from the cutting back of Tree Line No.1 to allow them more space to develop their crowns and to reduce competition.</p> <p>They would also benefit from the pruning of lower branches in order to improve clearance over the surrounding surfaces. Prune branch stubs back to proper target pruning points.</p> <p>Monitor the adjoining footpath surface for structural damage and carry out the necessary repairs.</p>	--

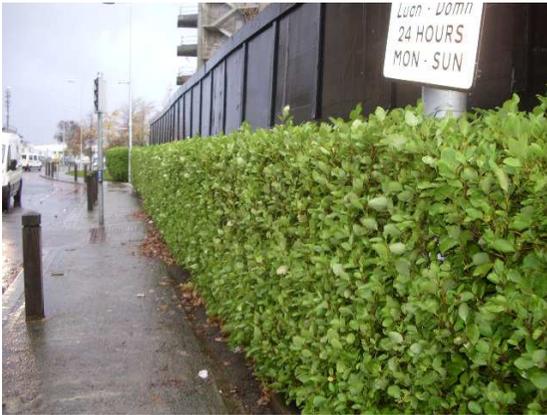
Tree No.	Tree Species	Ht. (m)	Stem Dia. (mm)	Branch Spread (m)	C-Ht. (m)	Age Class	Phys. Con.	Structural Condition Other Comments	Preliminary Recommendation	Remain Contribute in years	Cat. Grade									
								N-north S-south E-east W- west Phys.-physiological.	MS- multi-stemmed A- average											
								It has suffered a large bark wound on the lower trunk on the footpath side extending up to a height of c.1.2m with decay developing into the underlying timber; however there is good callous growth around this wound. 'Horse Chestnut Scale' is present throughout its crown. It is located c.6m west of the lamp pole.	Monitor its condition on a twelve monthly basis.											
Hedge No.1	Griselinia <i>Griselinia littoralis</i>	<p>Located on the public footpath side of the current site hoarding running from Tree Line No.2 westwards.</p> <p>It is an early-mature age class in fair/ good condition physiologically and in fair condition structurally. It has been clipped/ maintained as a low formal hedge with some gaps where sections have died or have been removed.</p> <table border="1" data-bbox="427 852 1167 951"> <thead> <tr> <th>Ht. (m)</th> <th>Stem Dia.(mm)</th> <th>Branch Spread (m)</th> <th>C-Ht. (m)</th> </tr> </thead> <tbody> <tr> <td>A 1.5</td> <td>--</td> <td>A 0.5N/0.5S</td> <td>A 0</td> </tr> </tbody> </table>								Ht. (m)	Stem Dia.(mm)	Branch Spread (m)	C-Ht. (m)	A 1.5	--	A 0.5N/0.5S	A 0	Continue present maintenance.		C2
Ht. (m)	Stem Dia.(mm)	Branch Spread (m)	C-Ht. (m)																	
A 1.5	--	A 0.5N/0.5S	A 0

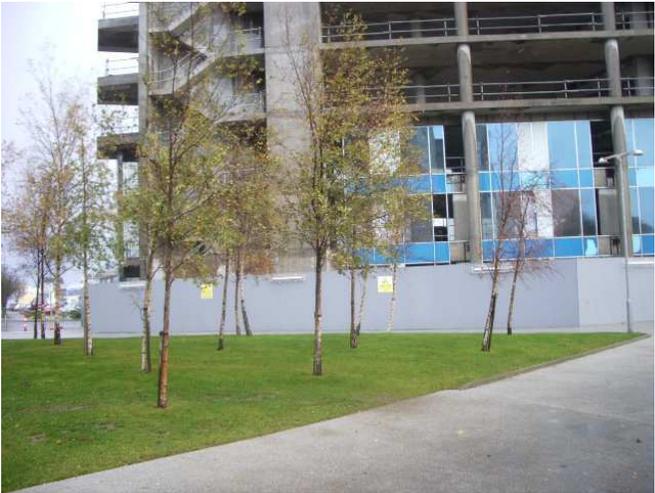
Tree No.	Tree Species	Ht. (m)	Stem Dia. (mm)	Branch Spread (m)	C-Ht. (m)	Age Class	Phys. Con.	Structural Condition Other Comments	Preliminary Recommendation	Remain Contribute in years	Cat. Grade							
								N-north S-south E-east W- west Phys.-physiological.	MS- multi-stemmed A- average									
Tree Group No.1	Birch <i>Betula pendula</i>	<p>Located along the western boundary of the site area and is on a triangular shaped open grass area surrounded by surfaces.</p> <p>The trees are of a young age class in fair condition both physiologically and structurally although some trees have been impacted upon by the drought of spring/summer this year and are most likely dead or dying as a result. They have been planted as a group at c.3m centres and have been planted into an area of soft landscape. The bulk of them are still attached to their tree ties and stakes. Some of these trees do not appear to have anchored successfully. Changes in the ground levels would appear to have occurred within this area since these trees were planted.</p> <table border="1" data-bbox="427 715 1167 810"> <thead> <tr> <th>Ht. (m)</th> <th>Stem Dia.(mm)</th> <th>Branch Spread (m)</th> <th>C-Ht. (m)</th> </tr> </thead> <tbody> <tr> <td>A 5</td> <td>A 60</td> <td>A 1N/1S/1E/1W</td> <td>A 2</td> </tr> </tbody> </table>						Ht. (m)	Stem Dia.(mm)	Branch Spread (m)	C-Ht. (m)	A 5	A 60	A 1N/1S/1E/1W	A 2	<p>They would benefit from their tree ties and stakes being adjusted where necessary or removed where no longer required.</p> <p>Remove those trees that are dead or at an advanced stage of decline.</p> <p>The changes in ground levels will need to be investigated further and works may need to be carried out in order establish the original ground levels.</p>		C2
Ht. (m)	Stem Dia.(mm)	Branch Spread (m)	C-Ht. (m)															
A 5	A 60	A 1N/1S/1E/1W	A 2

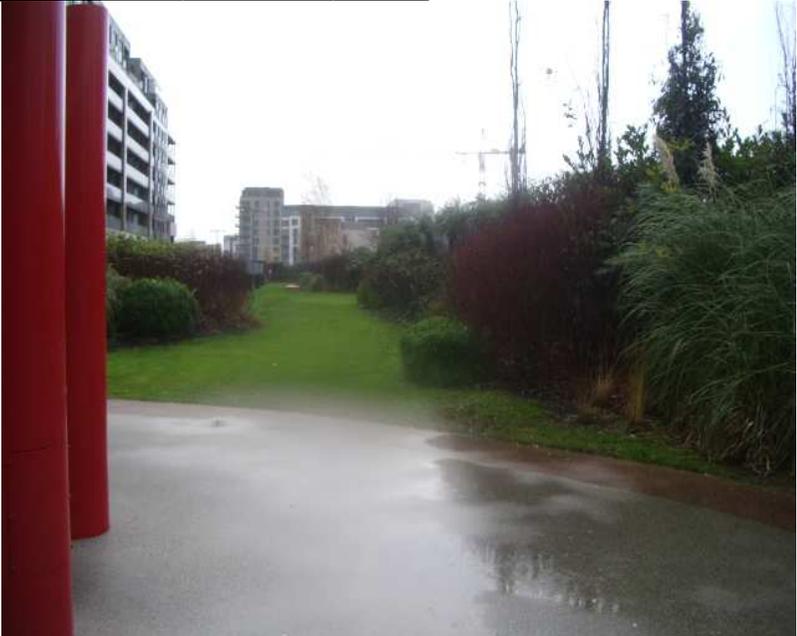
Shrub Border	Mixed Ornamental Shrubs	<p>Planted as part of the landscaping of the existing building to the north and consists of a linear shrub border of varying widths along its length running in an east-west direction.</p> <p>The shrubs have received regular trimming/cutting to contain as a low formal shrub border contained along a</p>						Continue present maintenance.		C2

Tree No.	Tree Species	Ht. (m)	Stem Dia. (mm)	Branch Spread (m)	C-Ht. (m)	Age Class	Phys. Con.	Structural Condition Other Comments	Preliminary Recommendation	Remain Contribute in years	Cat. Grade														
								N-north S-south E-east W- west Phys.-physiological.	MS- multi-stemmed A- average																
No.1	Fastigate Oak <i>Quercus fastigiata</i> Sorbus <i>Aucuparia cv.</i> Birch <i>Betula pendula</i> Pine <i>Pinus sp.</i>	boundary fence. It has some value for low screening between existing buildings and the site area that has only been partially developed.						Within this shrub border there are 14No. trees of a young age class that have been planted into it to give extra height. These include 6No. Sorbus, 7No. Fastigated Oak, 4No. Birch and 2No. Pines. Some trees are showing stress/decline and struggling to establish due to the drought period of spring/summer.

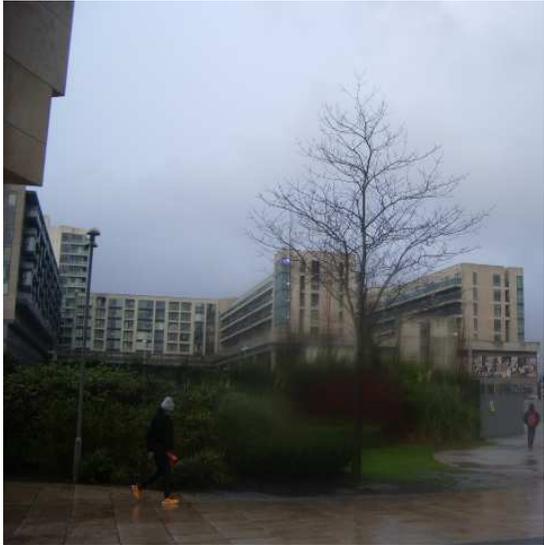
Tree No.	Tree Species	Ht. (m)	Stem Dia. (mm)	Branch Spread (m)	C-Ht. (m)	Age Class	Phys. Con.	Structural Condition Other Comments	Preliminary Recommendation	Remain Contribute in years	Cat. Grade
								N-north S-south E-east W- west Phys.-physiological.	MS- multi-stemmed A- average		
Tree No.11	Red Oak <i>Quercus rubra</i>	10	240	3N 3S 3E 3W	3	Young	Fair	Fair It is located on the edge of a hard landscape area. This tree was most likely planted as an extra-heavy standard feature tree and seems to be establishing itself well.	Requires no work at the present time.	20-40	B2
